# Manhole Inspection Summary

Manhole # S13WW1005MH

Insp Date: **10/2/06 10:25 AM**

**Location** Address: **2300 ENSLOW AVE**

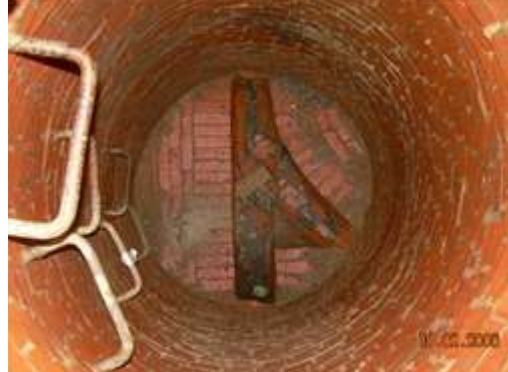
Top View

Barrel infiltration. Bench and Channel debris. Corroded steps.

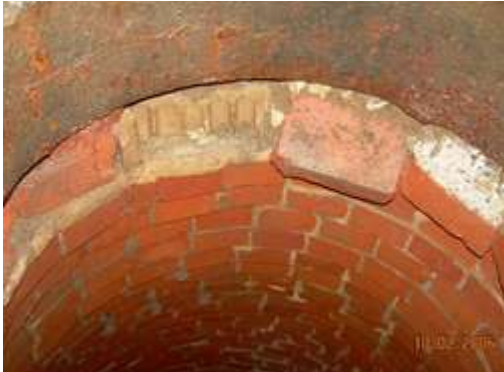
Defect

Frame leaks. Adjustment deterioration, loose brick, and infiltration.

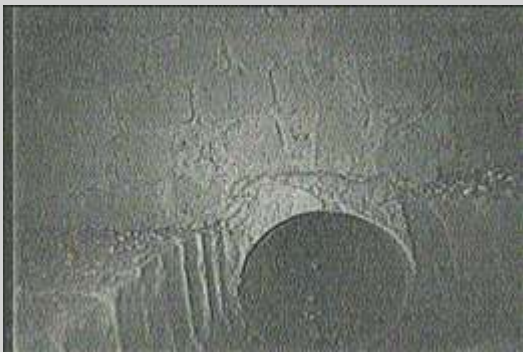
### 8 in. Circular Gravity Sewer Pipe Out @ 12 O'Clock

Deposits: ☐ None ☒ **Mud** ☐ Sludge ☒ **Debris** ☐ Grease

Infiltration: **None** Pipe Seal Cond: **Cracked**

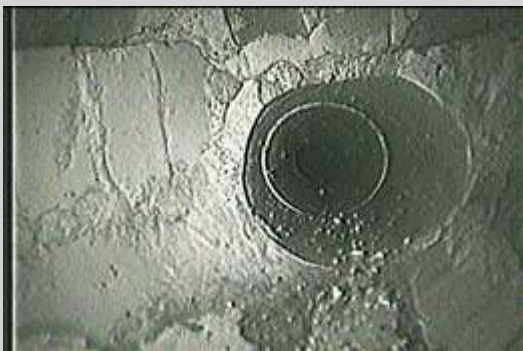
### 6 in. Circular Gravity Sewer Pipe In @ 4 O'Clock

Infiltration: **None** Pipe Seal Cond: **Broken**

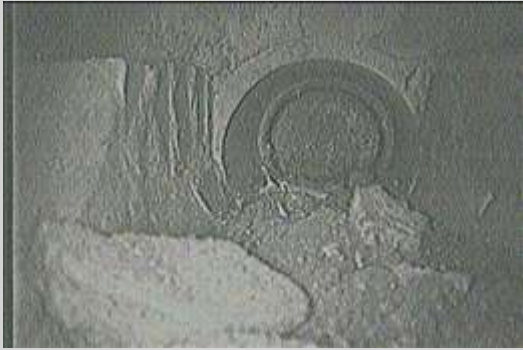
8 in. Circular Gravity Sewer

I6 pipe is plugged.

Deposits: ☐ None ☐ Mud ☐ Sludge ☒ **Debris** ☐ Grease

Silt Depth: **2** (in.)
